DEPARTMENT OF TRANSPORTATION**DIVISION OF ENGINEERING SERVICES**

Contract #: 04-0120F4Cty: SF/Ala Rte: 80 PM: 13.2/13.9File #: 69.28**WELDING INSPECTION REPORT****Resident Engineer:** Pursell, Gary**Address:** 333 Burma Road**City:** Oakland, CA 94607**Report No:** WIR-016070**Date Inspected:** 02-Aug-2010**Project Name:** SAS Superstructure**OSM Arrival Time:** 1900**Prime Contractor:** American Bridge/Fluor Enterprises, a JV**OSM Departure Time:** 700**Contractor:** Zhenhua Port Machinery Company, Ltd (ZPMC), Changxing Island **Location:** Shanghai, China**CWI Name:** See below**CWI Present:** Yes No**Inspected CWI report:** Yes No N/A**Rod Oven in Use:** Yes No N/A**Electrode to specification:** Yes No N/A**Weld Procedures Followed:** Yes No N/A**Qualified Welders:** Yes No N/A**Verified Joint Fit-up:** Yes No N/A**Approved Drawings:** Yes No N/A**Approved WPS:** Yes No N/A**Delayed / Cancelled:** Yes No N/A**Bridge No:** 34-0006**Component:** Tower and OBG Components**Summary of Items Observed:**

WELDING INSPECTION REPORT

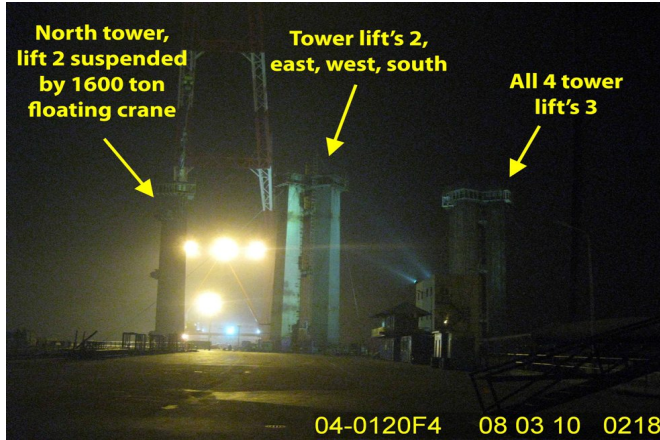
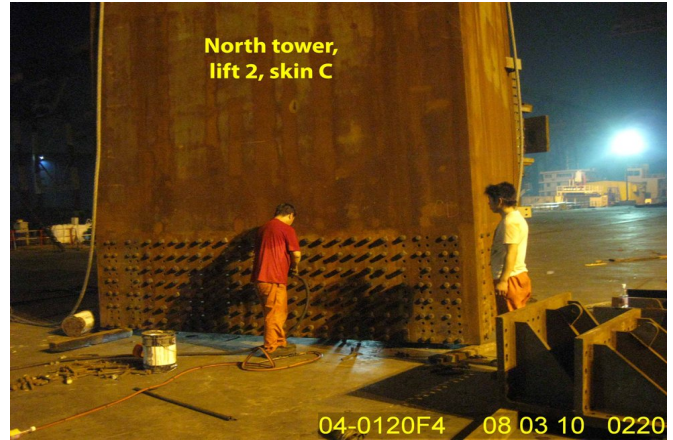
This QA Inspector observed no apparent welding related work was being performed on the Heavy Dock. All 4 tower lift's 3 were connected and positioned on a base pedestal. Tower lift's 2 east, south, and west appeared to be connected and positioned on another base pedestal. A ZPMC 1600 ton floating crane was rigged to the top of north tower, lift 2 with the bottom of north tower, lift 2 touching on dunnage on the deck of the dock. ZPMC personnel were working at the bottom of north tower, lift 2 appearing to be removing temporarily bolted splice plate assemblies. See photos below.
